千葉県勝浦市興津地区の津波避難リスクに関する調査 Survey on Tsunami Evacuation Risk in Okitsu Area, Katsuura-shi, Chiba

○星上幸良¹, 小林昭男¹*Yukiyoshi Hoshigami¹, Akio Kobayashi¹

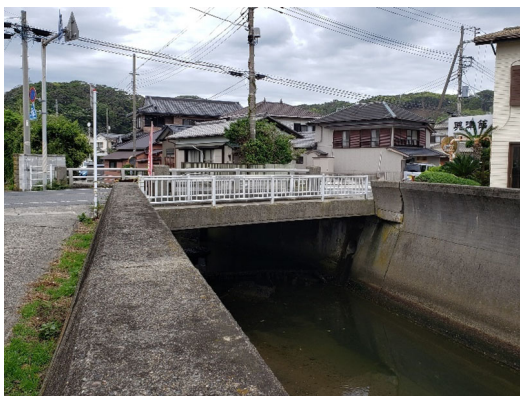
Figure2. Non-seismic bridge

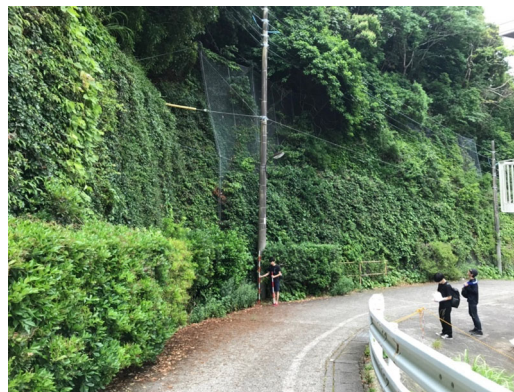
Figure3. Steep slope on evacuation route

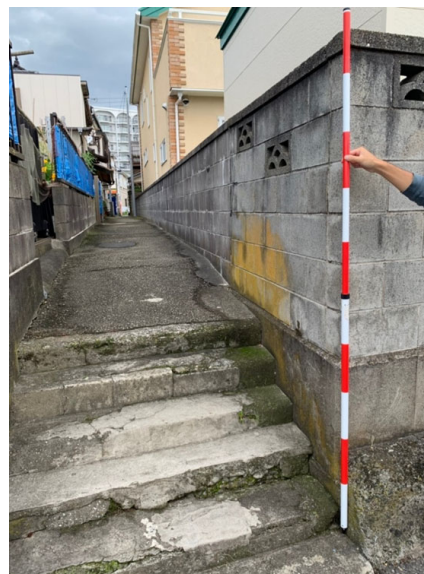
Figure4. A narrow passage in a residential area where there is a risk of falling objects
